Semiannual Progress Report  
Determination of the Emissivity of Materials  
Contract NAS3-4174

Report Period: November 15, 1965 through May 14, 1966

Technical Management: National Aeronautics and  
Space Administration, Lewis Research Center  
Space Power Systems Division  
R. L. Davies and J. A. Milko

The testing of coatings applied to AISI-310 stainless steel and columbium-1 percent zirconium was continued during the report period. In addition, the study of the adherence, compatibility, and emittance of coatings applied to beryllium was completed.

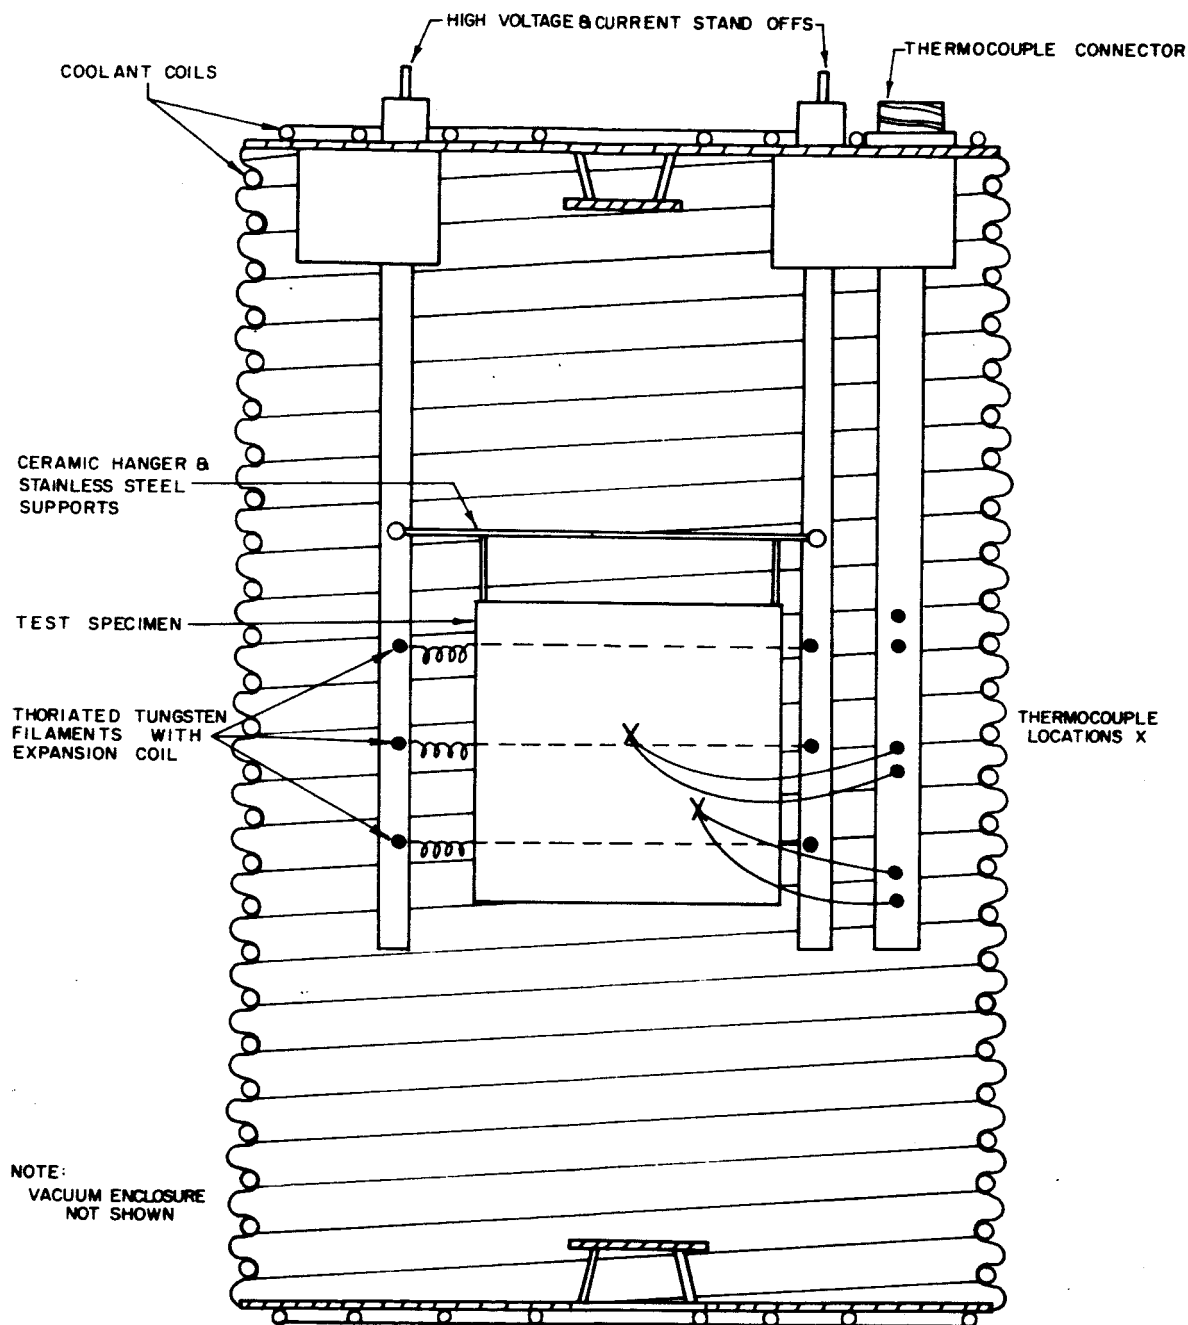
Figure 4 Schematic Drawing of Specimen Installation in Thermal Decay Emittance Test Apparatus

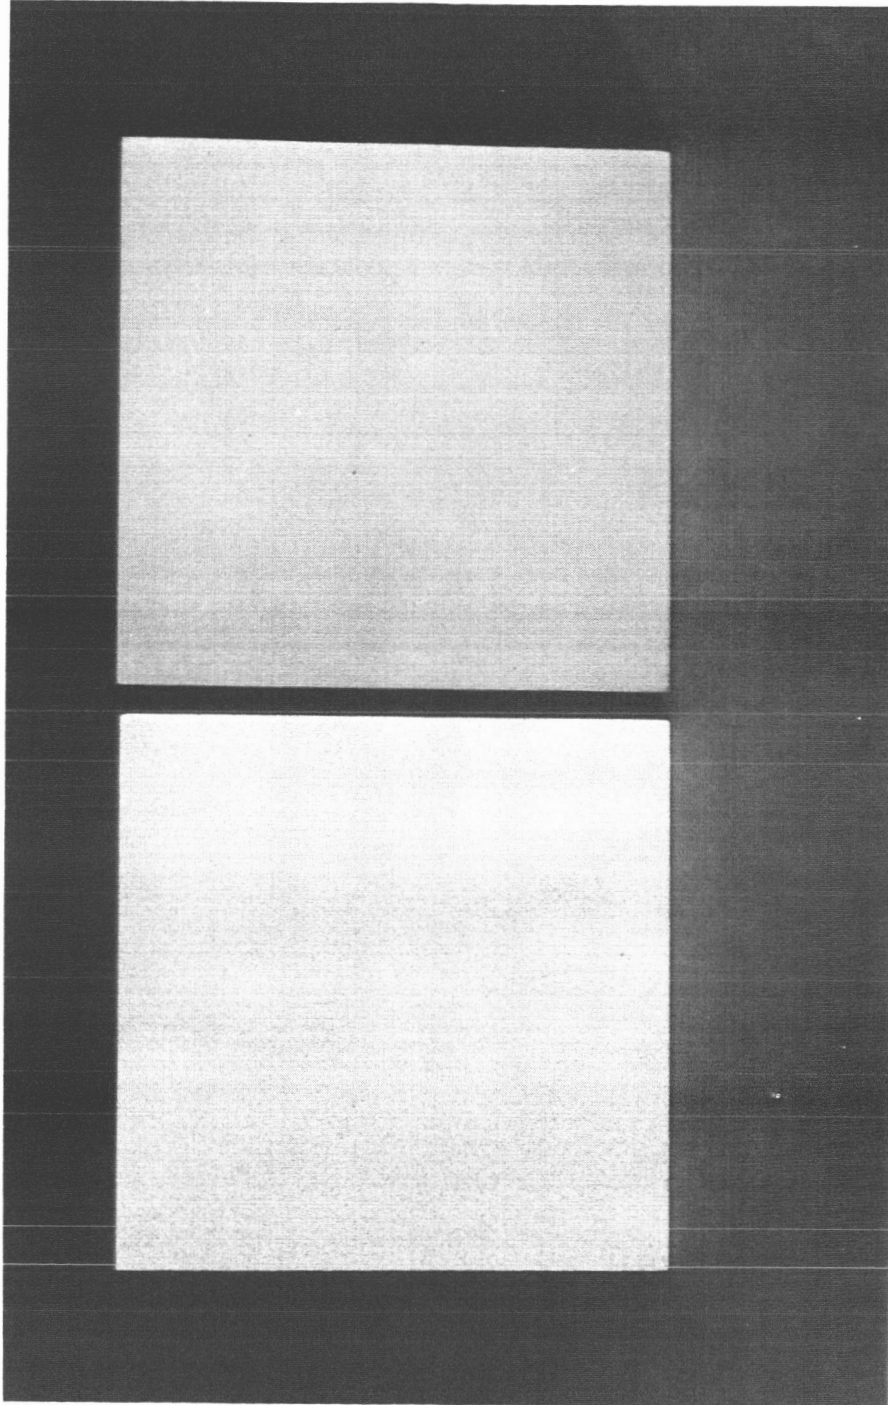
Figure 5 Appearance of Calcium-Titanate-Coated Beryllium Plate Before (Left)  
and After (Right) Being Aged at 800°F for 1000 Hours XP-66871

After being aged at 800°F for 1000 hours, the specimens exhibited no changes in appearance other than a slight darkening of the coating (see Figure 5). As shown, no cracking, spalling, or indication of bond disruption occurred.

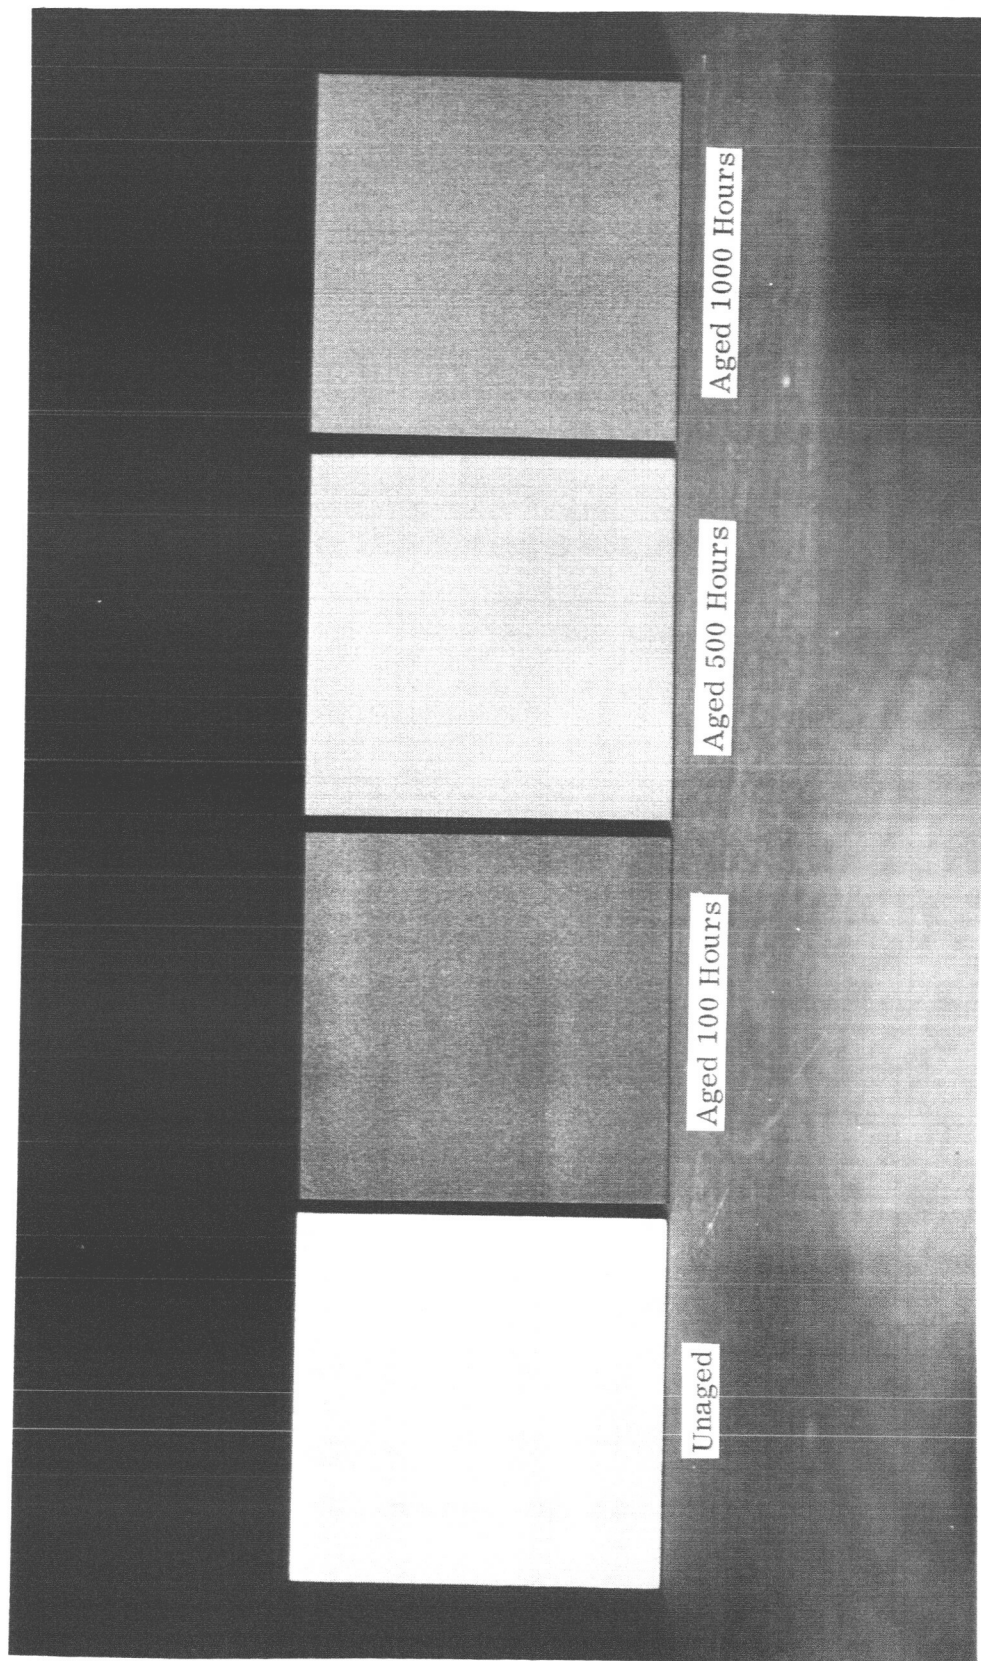
Figure 6 Appearance of Calcium-Titanate Coated Beryllium Plates Before  
Aging and After Aging at 1400°F for 100 Hours, at 1200°F for 500  
Hours, and at 1200°F for 1000 Hours  
Mag: 0.6X  
XP-66878

Three calcium-titanate-coated plates were aged at 1400°F for 100 hours in a vacuum of  $1 \times 10^{-8}$  mm Hg. As shown in Figure 6, the coating was considerably darker after aging than before, although the texture was unchanged, and no cracking or spalling of the coating was observed. Spectrographic analysis of the coating detected the presence of beryllium, and X-ray diffraction analysis detected the probable presence of BeO. Since the aging conditions were known to be marginal with respect to the vapor pressure of beryllium, and since it appeared that vaporization had, in fact, occurred, it was decided that the maximum aging temperature should be lowered to 1200°F.

Subsequently, two additional groups of specimens were aged at 1200°F, one for 500 hours and the other for 1000 hours. As shown in Figure 6, the specimens were darker after aging than before, with the color change being greater for the specimens aged for the longer period. However, the color change for these specimens was always less than that for the specimens aged at 1400°F. No spalling, cracking, or change in texture occurred.

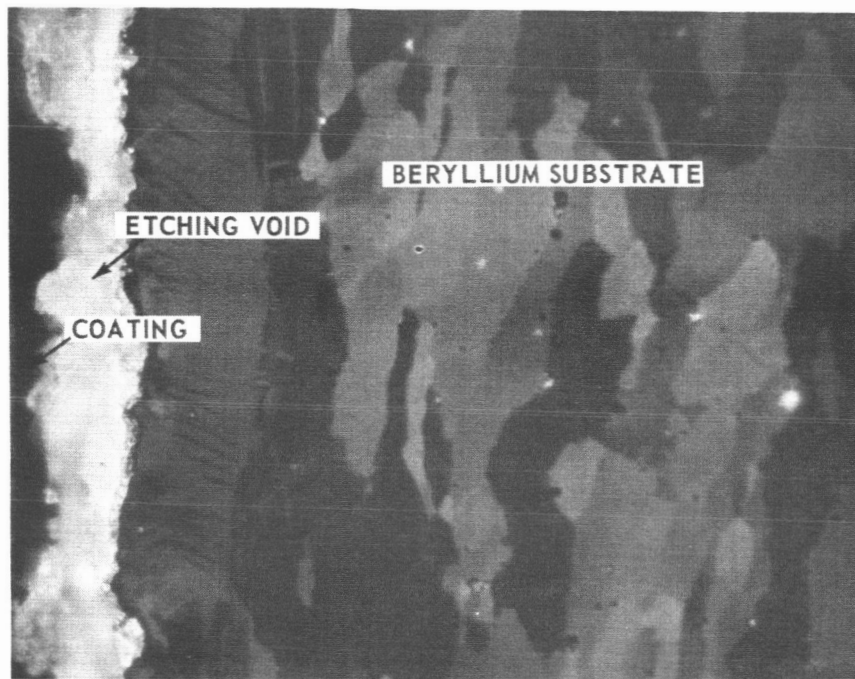
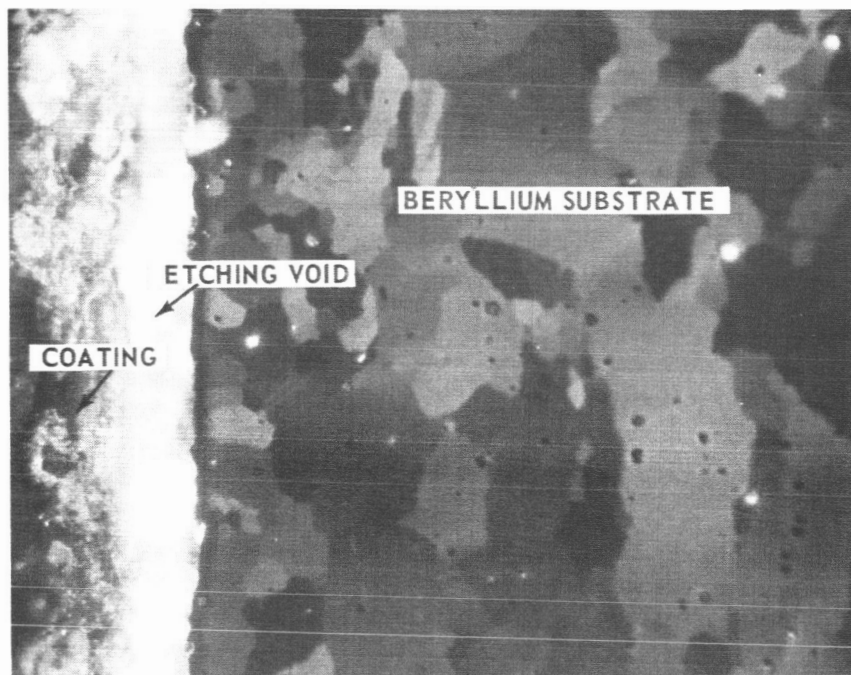
Figure 7 Typical Cross Sectional Photomicrographs of Calcium-Titanate-Coated Beryllium Plates Aged for 1000 Hours at 800°F (Top) and 1200°F (Bottom)

Photomicrographs were taken of one specimen from each test. The microstructure of all specimens remained unchanged as a result of aging, except for those aged at 1400°F. These specimens exhibited some annealing, as expected. Typical photomicrographs of a specimen aged for 1000 hours at 800°F and 1200°F are shown in Figure 7. The beryllium for these specimens was received in the first shipment and exhibits the elongated structure characteristic of that shipment.

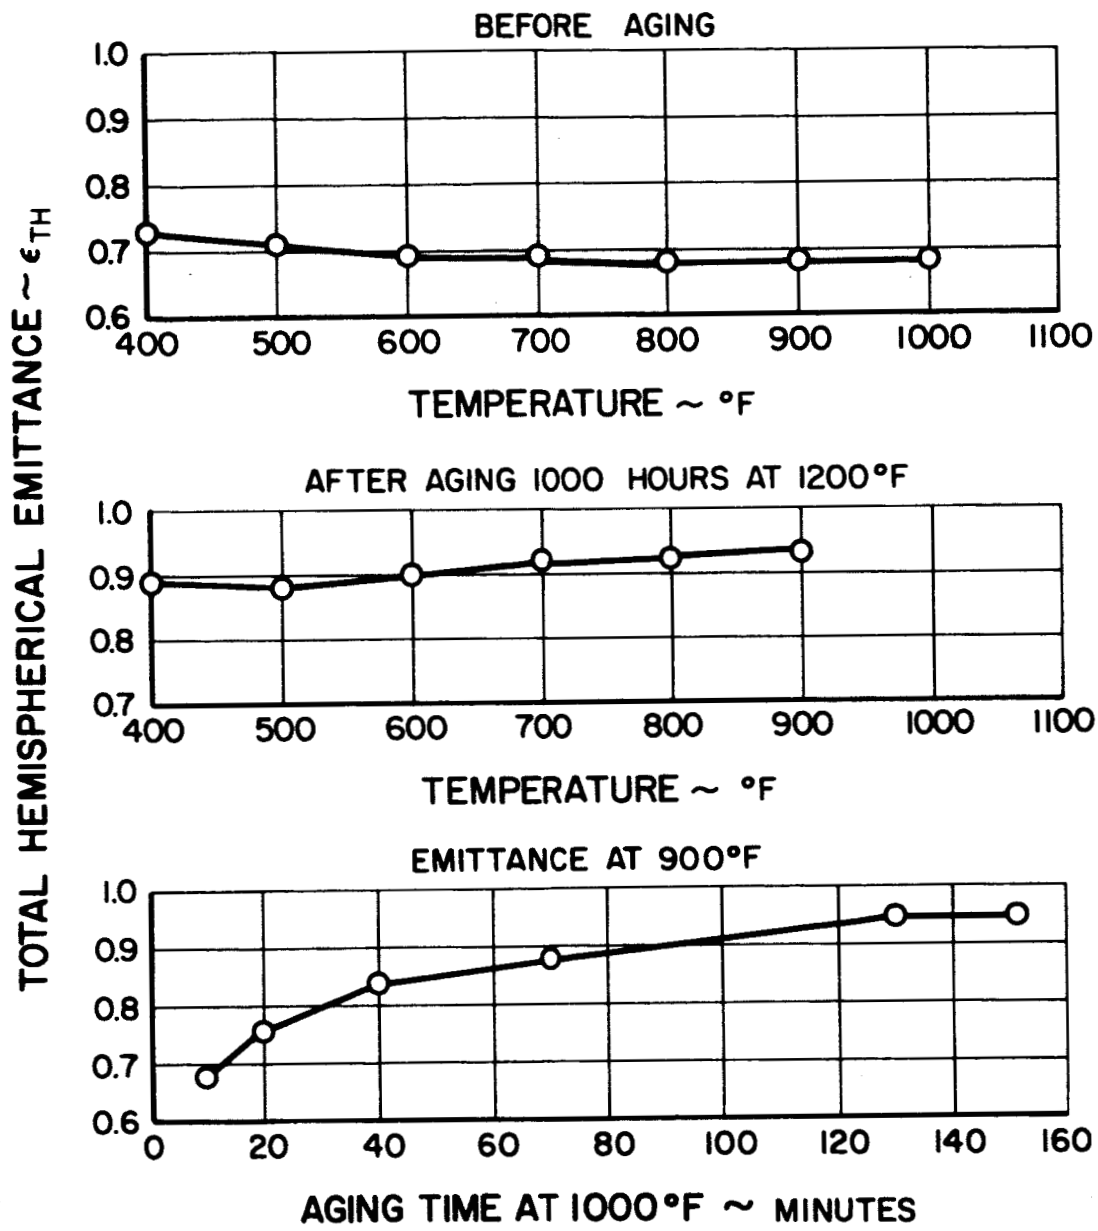
Figure 8 Total Hemispherical Emittance Measurement Results for Calcium-Titanate-Coated Beryllium Plates Using Thermal Decay Method

Additional tests were conducted on unaged and aged coated plates in the thermal decay apparatus. The emittance of the unaged specimen ranged between 0.73 at 400°F and 0.68 at 1000°F as shown in Figure 8. Subsequently, the emittance of a specimen which had been aged at 1200°F for 1000 hours was measured, and the emittance was found to range between 0.89 at 400°F and 0.92 at 900°F (see Figure 8). The increase in emittance produced by aging was expected since previous short-term endurance tests of calcium-titanate-coated stainless steel had shown similar trends. The process is similar to a curing process, since the coating maintains the higher emittance level once it is attained.

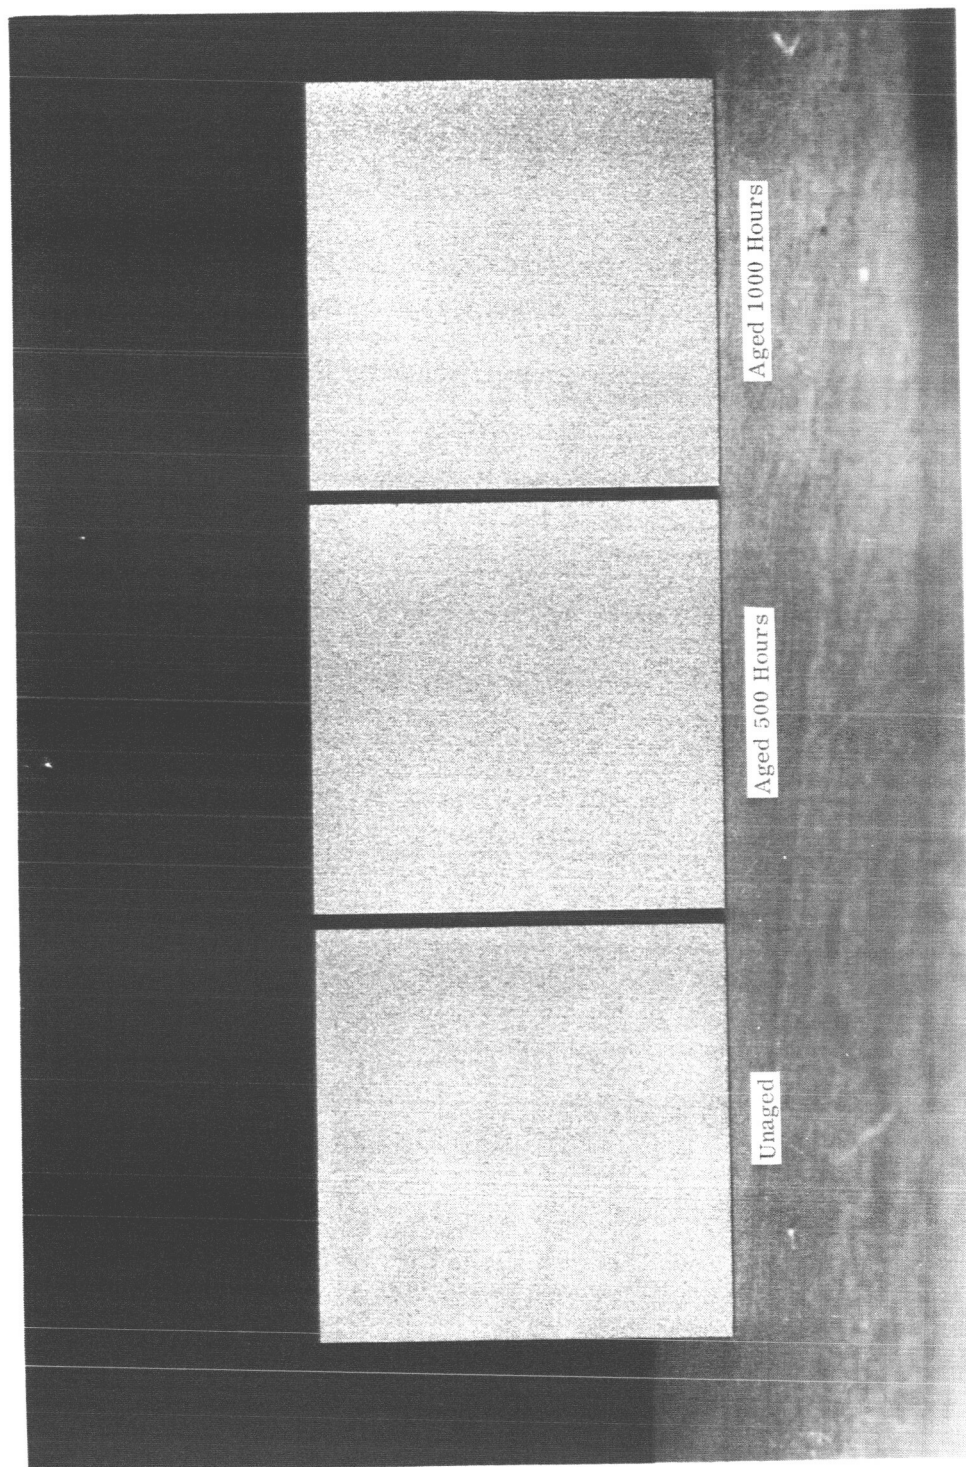
Figure 9 Appearance of Iron-Titanate-Coated Beryllium Plates Before Aging  
and After Aging at 800°F for 500 and 1000 Hours  
XP-66874

The appearance of typical specimens aged at 800°F for 500 and 1000 hours is shown in Figure 9. As shown, the specimens were slightly darker after aging than before, but no cracking or spalling occurred.

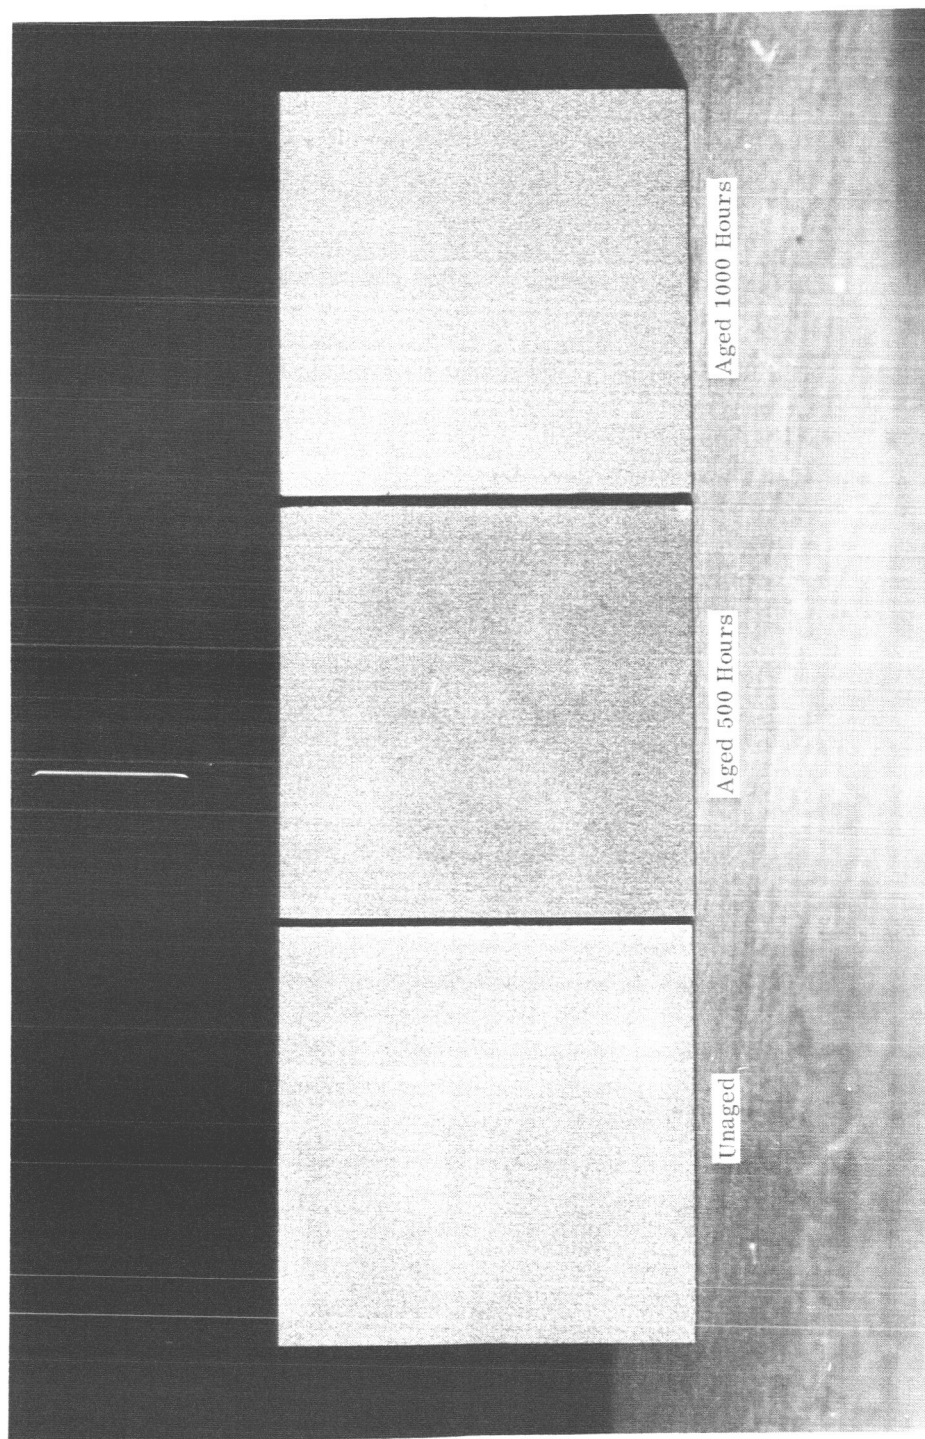
Figure 10 Appearance of Iron-Titanate-Coated Beryllium Plates Before Aging and After Aging at 1200°F for 500 and 1000 Hours XP-66875

Subsequently, iron-titanate-coated plates were satisfactorily aged at 1200°F for 500 and 1000 hours. As shown in Figure 10, no cracking or spalling occurred, and the coatings were only slightly darker after aging than before. In view of the results from these tests, it was not considered necessary to age iron-titanate-coated specimens at 1200°F for 100 hours.

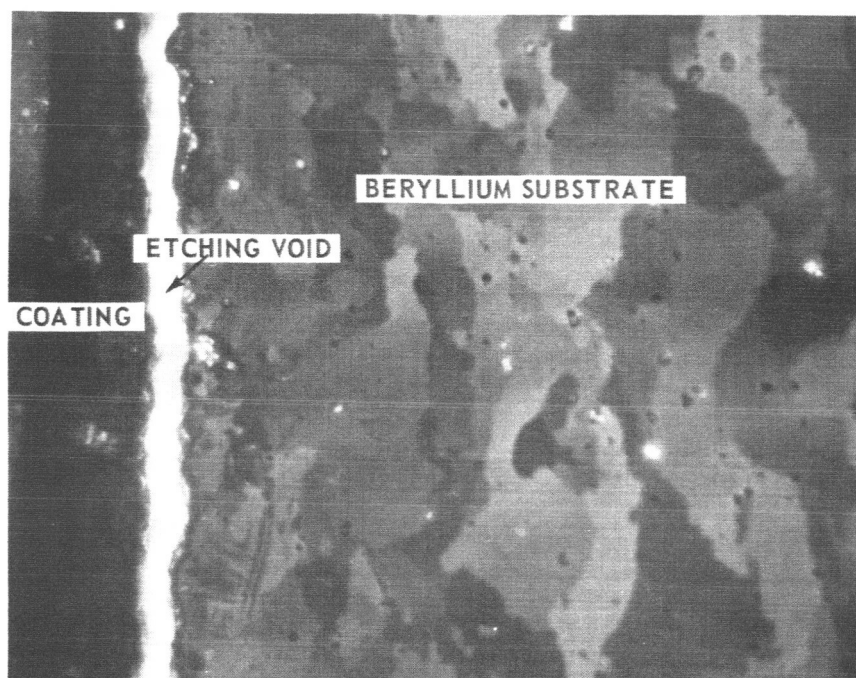
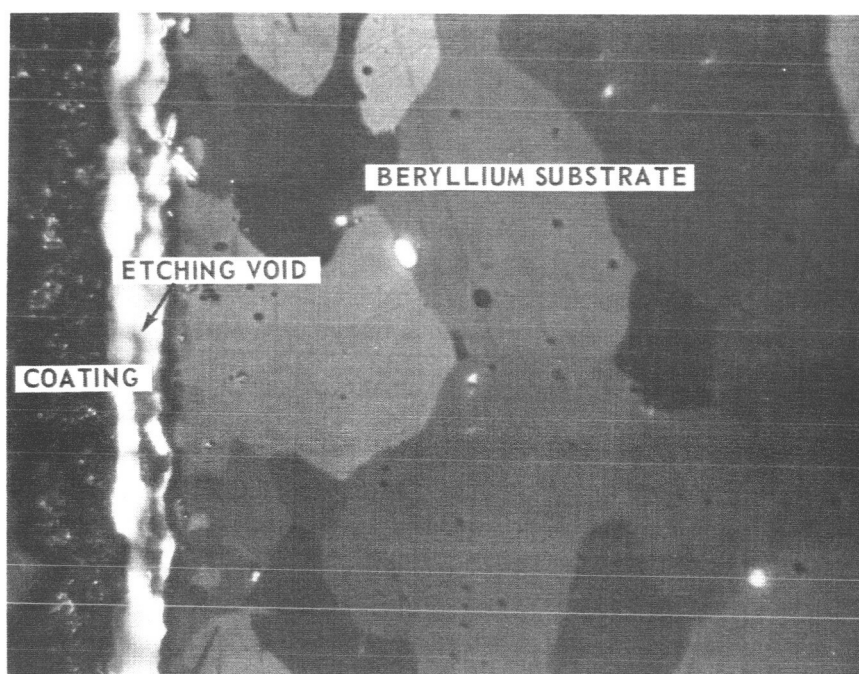
Figure 11 Typical Cross Sectional Photomicrographs of Iron-Titanate-Coated Beryllium Plates Aged for 1000 Hours at 800°F (Top) and 1200°F (Bottom)

Examination of the microstructures of the specimens revealed no changes from those of unaged specimens. Typical photomicrographs of specimens aged for 1000 hours at 800°F and 1200°F are shown in Figure 11. The beryllium for the specimen tested at 800°F was received in the first shipment and that for the specimen tested at 1200°F was received in the second shipment.

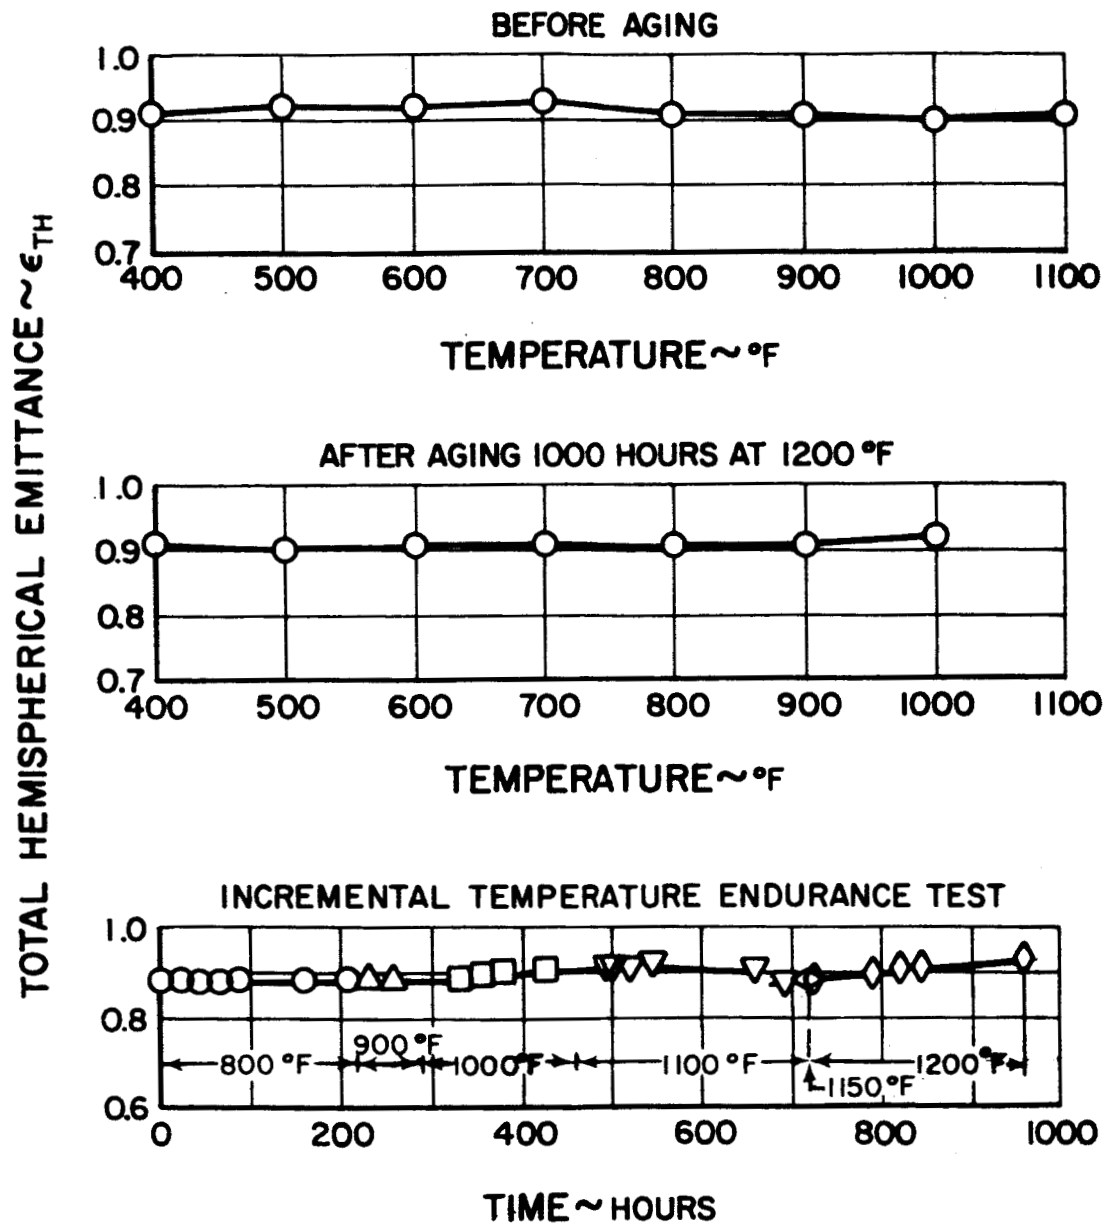
Figure 12 Total Hemispherical Emittance Measurement Results for Iron-Titanate-Coated Beryllium

b. Emittance Tests - The emittance of iron-titanate-coated beryllium was measured through steady-state testing and through thermal-decay testing. Emittance values are presented in Figure 12.

Two coated beryllium plates were tested by the thermal decay method. One plate was unaged and the other had been aged for 1000 hours at 1200°F. In both cases, the emittance was about 0.91 over the entire temperature range from 400°F to 1000°F, as shown in Figure 12.

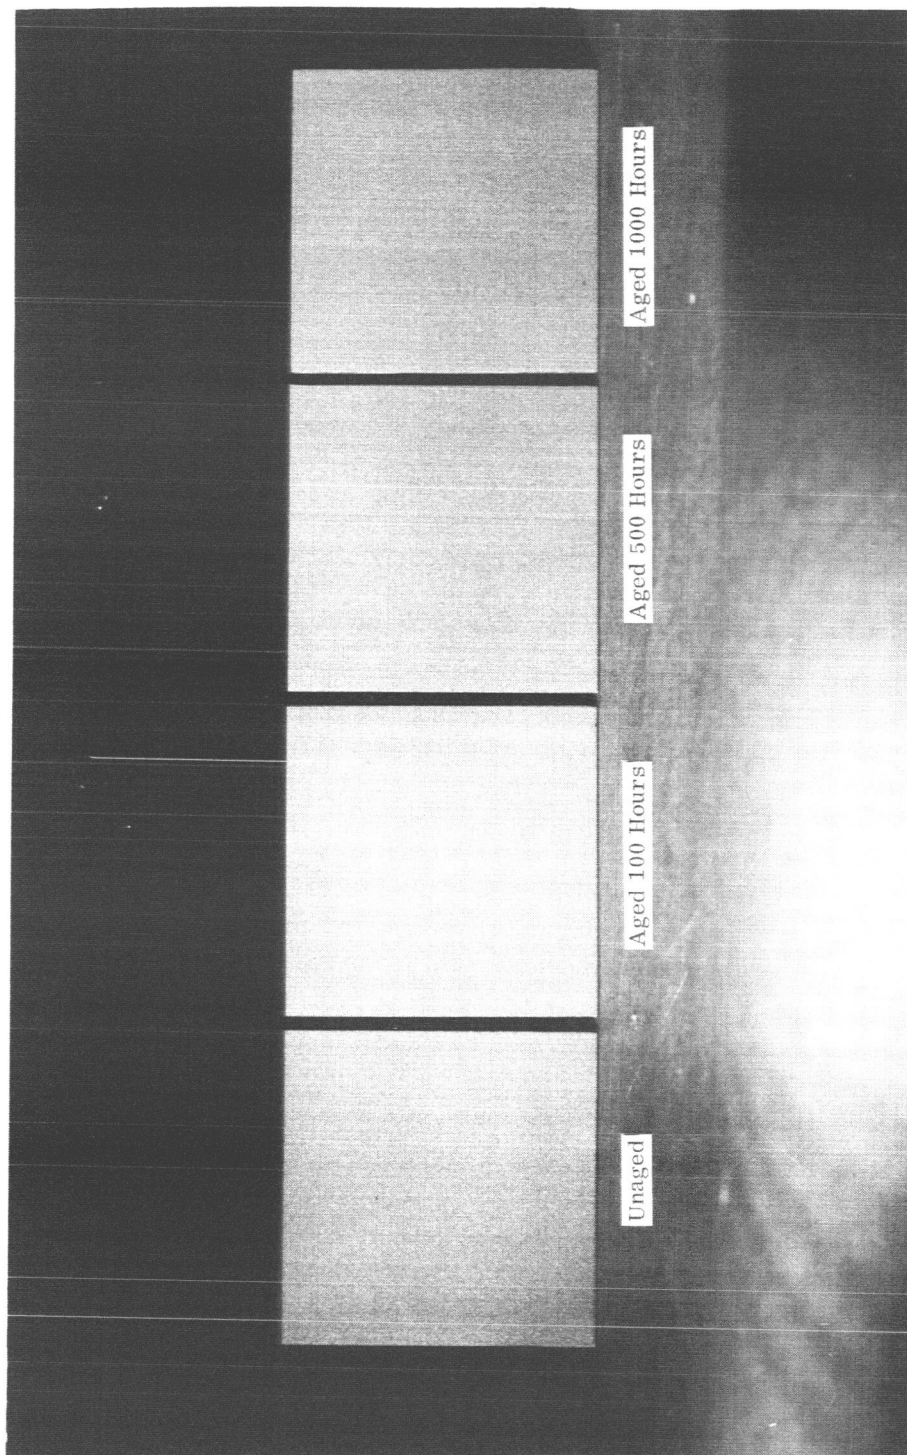
Figure 13 Appearance of Zirconium-Titanate-Coated Beryllium Plates Before Aging and After Aging at 800°F for 100, 500, and 1000 Hours  
Mag: 0.6X  
XP-66876

c. Aging Tests - Zirconium-titanate coated beryllium plates were aged at 800°F for 100, 500, and 1000 hours and at 1200°F for the same periods. Three plates were aged in each test. After aging, the specimens aged for the longer periods were slightly darker than the unaged specimens, but the color change was small, as shown in Figures 13 and 14. In no case was there any cracking, spalling, or other indication of coating separation.

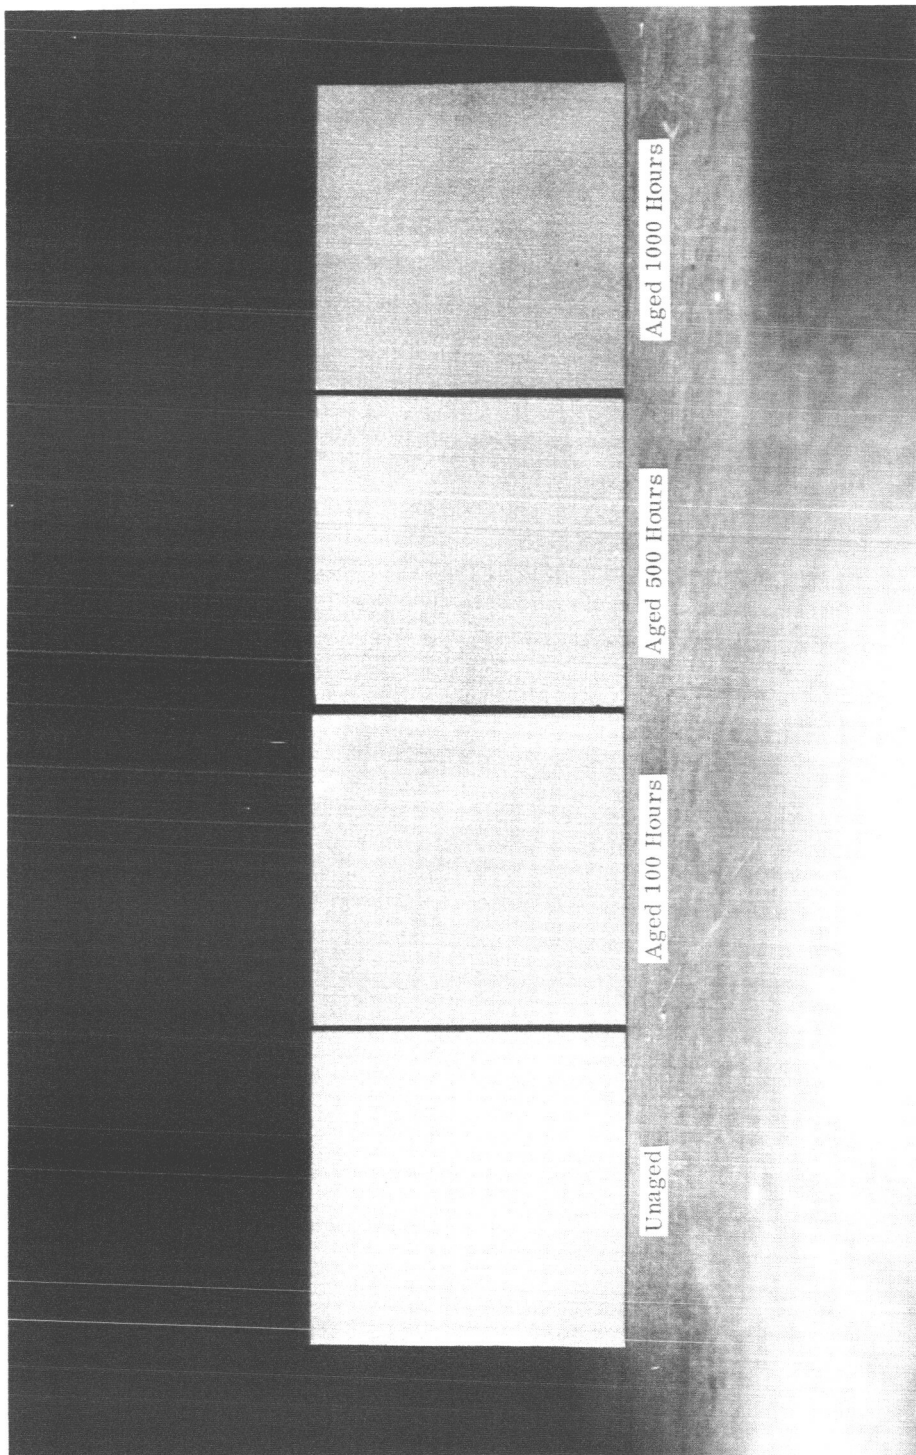
Figure 14 Appearance of Zirconium-Titanate-Coated Beryllium Plates Before Aging and After Aging at 1200°F for 100, 500, and 1000 Hours

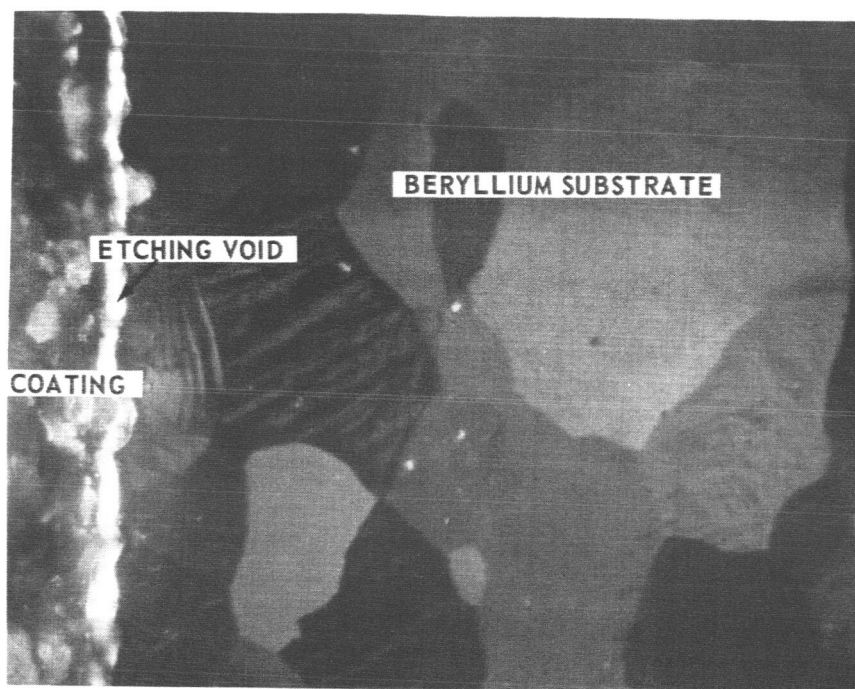
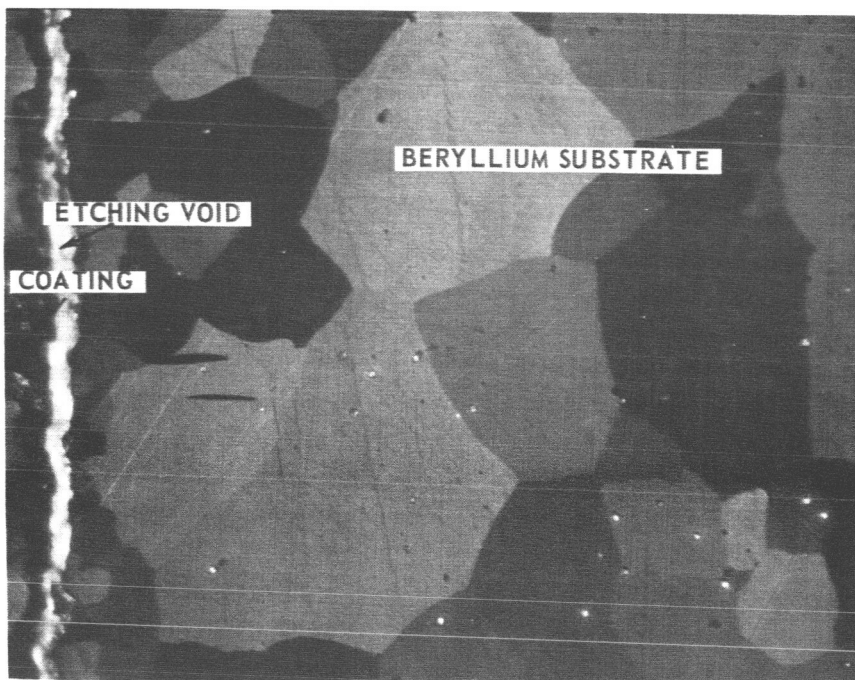
Figure 15 Typical Cross Sectional Photomicrographs of Zirconium-Titanate-Coated Beryllium Plates Aged for 1000 Hours at 800°F (Top) and 1200°F (Bottom)

Photomicrographs were taken of all specimens, and the results revealed no changes in microstructure caused by aging. Typical photomicrographs for a specimens aged at 800°F and 1200°F for 1000 hours are shown in Figure 15. The beryllium for these specimens was received in the second shipment.

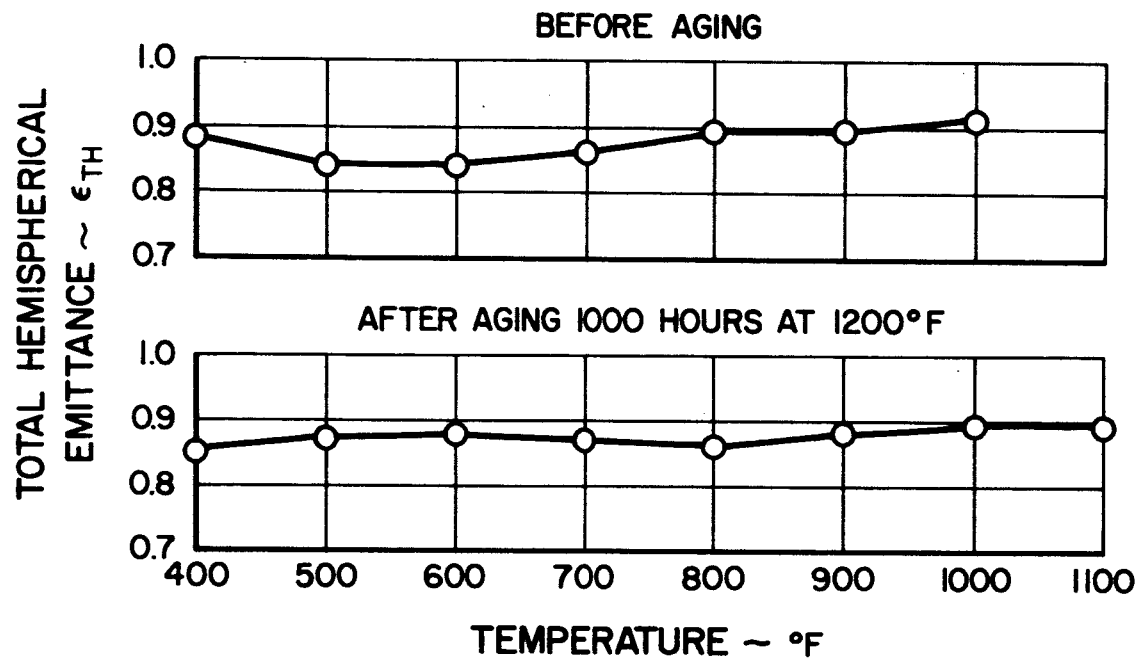
Figure 16 Total Hemispherical Emittance Measurement Results for Zirconium-Titanate-Coated Beryllium Plates

d. Emittance Tests - Total hemispherical emittance measurements were made on zirconium-titanate-coated beryllium specimens by the thermal decay method. Both unaged specimens and specimens which had been aged at 1200°F for 1000 hours were tested. The emittance values obtained were similar for both specimens, varying from 0.84 to 0.91 over the temperature range of 400°F to 900°F. These values are shown in Figure 16.

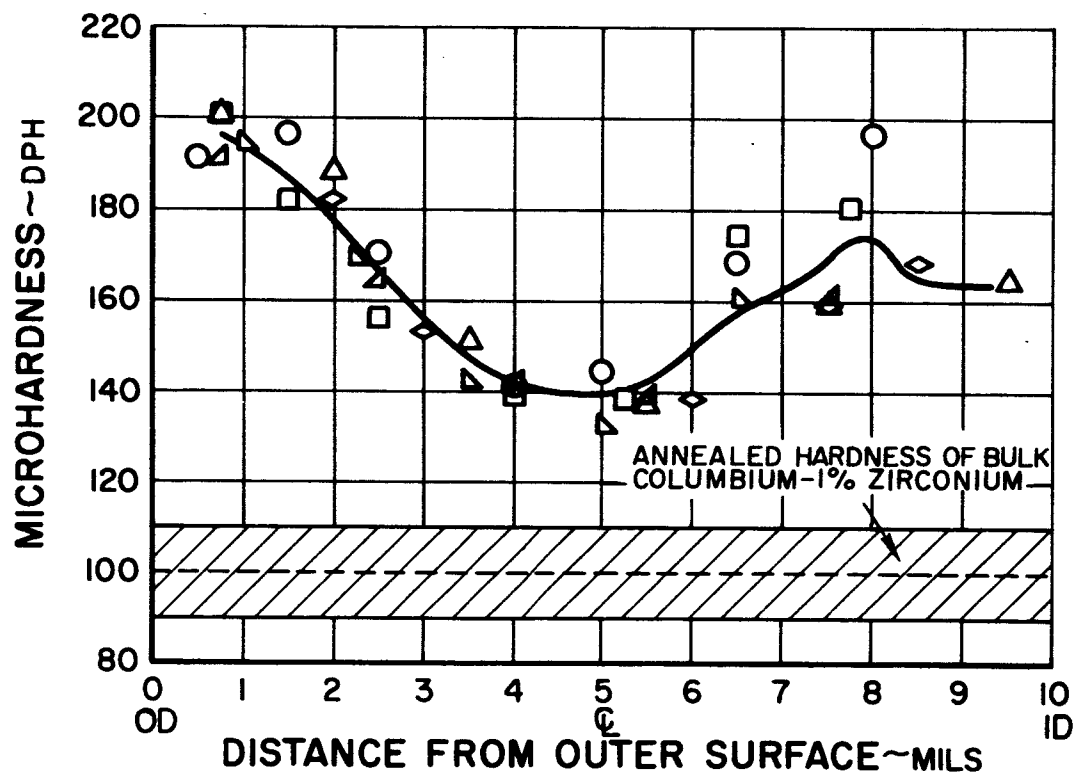
Figure 17 Microhardness Traverse Results for Endurance-Tested Columbium-1 Percent Zirconium Tube Coated With Iron-Titanate

Microhardness traverses were made on cross-section samples of a columbium-1 percent zirconium tube in the as-received condition and on the coated tube after endurance testing. The as-received tube had an average diamond pyramid hardness of 145 kg/mm<sup>2</sup>, with essentially no difference in hardness between the surfaces and the center of the cross-section. The hardness level measured indicates that the material received on the order of 50 percent cold working following the last heat treatment. A total of six traverses were made across the endurance-tested sample, and, as shown in Table 10 and Figure 17, the hardness was considerably higher close to the surfaces than towards the center of the cross-section, with gradients extending inward about 3 or 4 mils from both surfaces. The hardness at the center of the cross-section is essentially the same as that of the untested tube. The gradients beneath the outer surface were relatively smooth and reproducible, whereas the data for the gradient beneath the inner surface was somewhat erratic. This behavior indicates that diffusion occurred during endurance testing and, possibly, that the diffusion across the outer surface was more uniform than that across the inner surface.

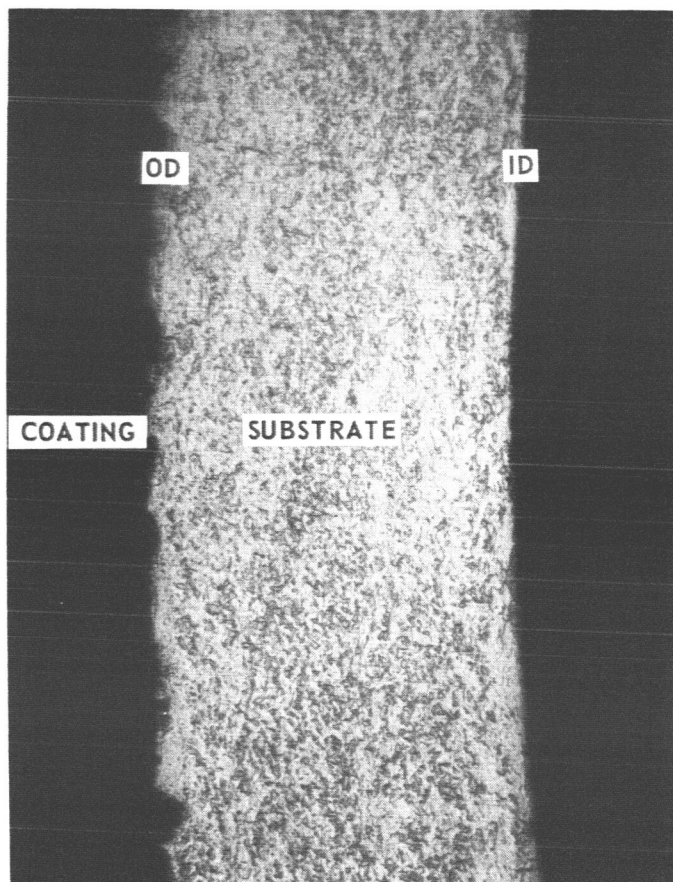
Figure 18 Cross Sectional Photomicrograph of Columbium-1 Percent Zirconium Tube After Being Coated With Iron Titanate

Samples of the columbium-1 percent zirconium material were examined metallographically both before and after endurance testing. The appearance of the substrate after coating and before endurance testing is shown in Figure 18. The microstructure is typical of that for cold-worked columbium-1 percent zirconium. After testing, the microstructure indicates that extensive, but still incomplete, recrystallization occurred (Figure 19). In addition, individual grains are visible on the substrate surface of the coating-substrate interface (see Figure 20). These grains are different in appearance from the remainder of the substrate and may be indicative of the formation of a new phase through interaction of the coating and substrate during testing. (The white regions on both sides of the section are nickel plating applied before polishing to prevent rounding of the specimen edges).

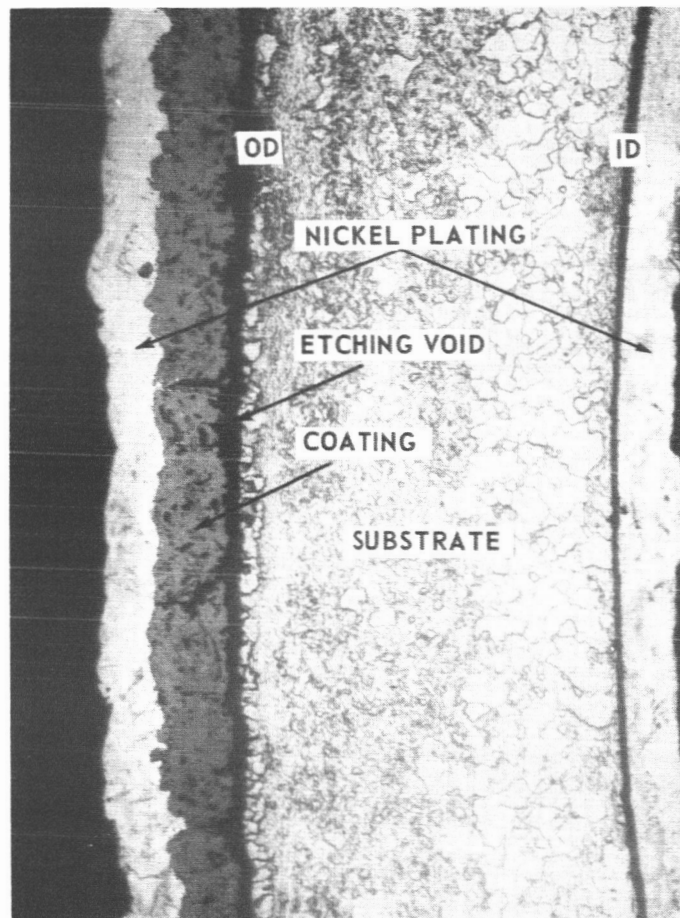
Figure 19 Cross Sectional Photomicrograph of Iron-Titanate-Coated  
Columbium-1 Percent Zirconium Tube After Endurance Testing  
at 1700°F for 10,000 Hours

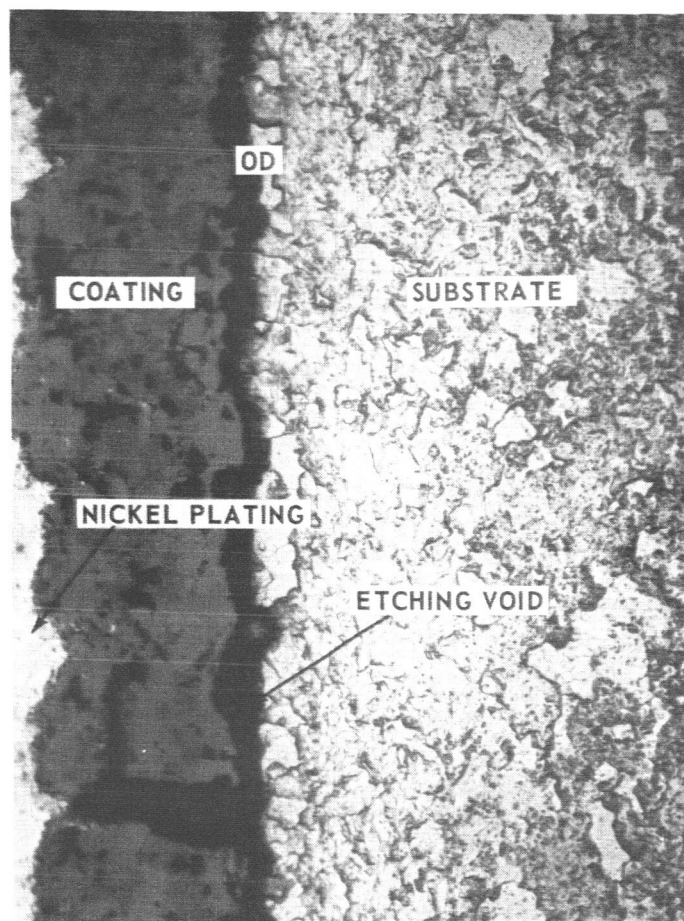
Figure 20

Cross Sectional Photomicrograph of Iron-Titanate-Coated  
Columbium-1 Percent Zirconium Tube After Endurance  
Testing at 1700°F for 10,000 Hours
